Electroless Nickel / Electroless Palladium / Immersion Gold Plating Process for Gold and Aluminum-Wire Bonding Designed for High-Temperature Applications

Kuldip Johal, Sven Lamprecht and Hugh Roberts
Atotech Deutschland GmbH, Berlin, Germany
Atotech USA Inc., Rock Hill, SC, USA

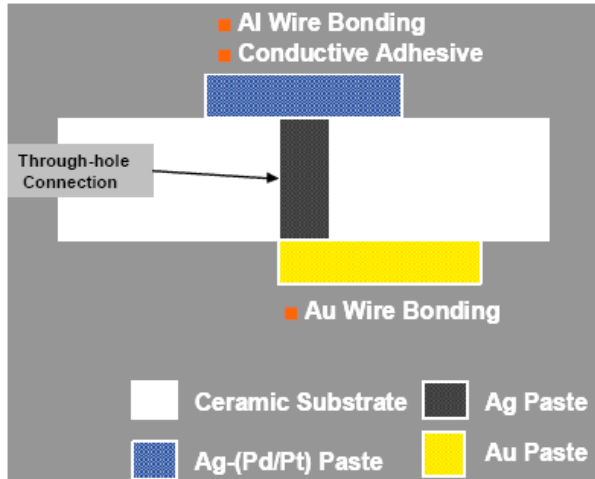
Fig 1. Typical application for thick film on ceramic substrates (simplified)

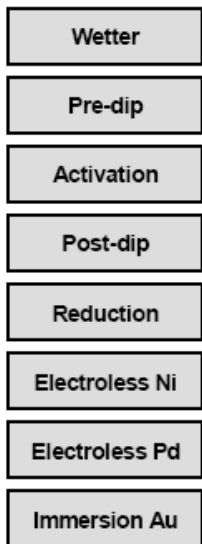
As a final finish, the proposed electroless nickel / electroless palladium / immersion gold (Ni/Pd/Au) plating process meets the technical requirements while offering the possibility for cost reduction. The process provides a selectively deposited Ni/Pd/Au directly on the pre-treated ceramic substrates. When combined with stencil printing of silver paste, Ni/Pd/Au can be used for hightemperature applications in mass production. Due to the nature of the process, the initial screen-printed paste underlying the Ni/Pd/Au must first be activated, enabling the deposition of an autocatalytic Nickel-Phosphorous (7-9% P by wt.) layer. This deposit is then covered by a thin autocatalytic-plated pure palladium layer, containing 99.99% Pd. Finally, a “flash” layer of immersion gold (30-50 nm) is deposited.

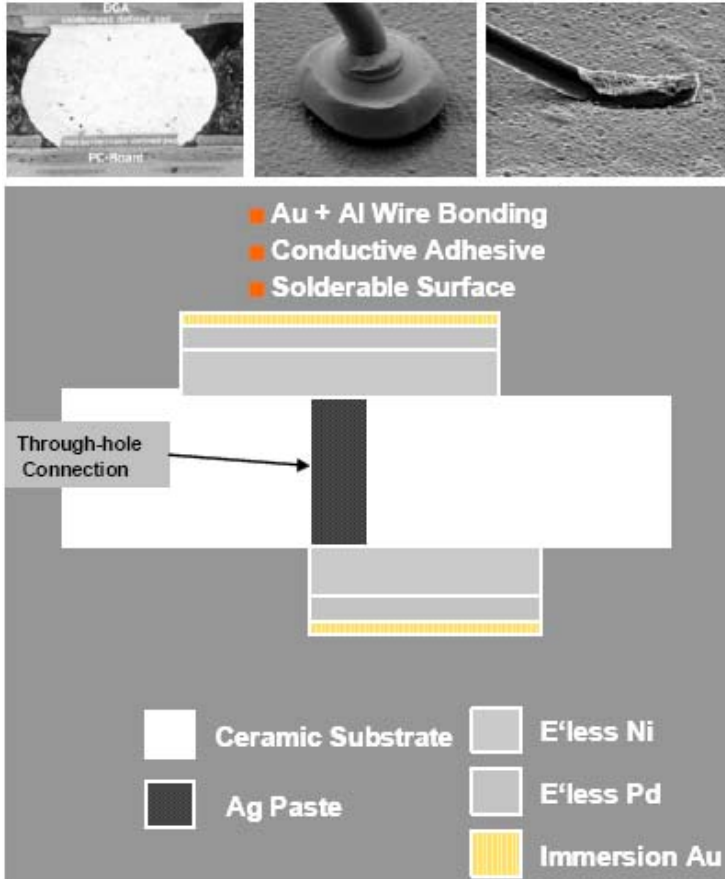
Fig. 2 Application of Ni/Pd/Au for multi-functional finish of ceramic material

This layer combination of pure palladium and gold enables both aluminium- and gold-wire bonding on the same surface, thus eliminating the need for two different screenprinted pastes. All surfaces of the printed structures are fully covered, including sidewalls. In addition to eliminating the use of costly gold paste, this technique eliminates any capital costs for electroplating and photolithography equipment.

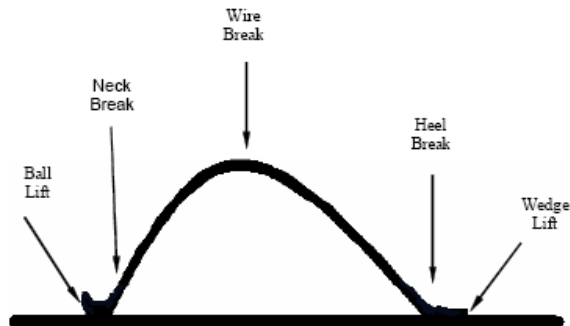
Fig. 3 Wire bond failure modes

Pull forces and fracture modes were recorded at the test intervals indicated in Table 5. Failure modes were investigated with the use of an optical stereo microscope.

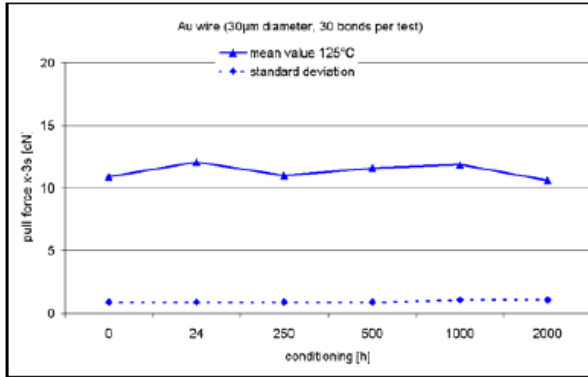
Figure 4 shows the mean values and standard deviations of the pull forces required to break the wire bonds in the 125°C dry-heat conditioning test. As shown, all values exceed the pass criteria range of 5.5 to 7.5 cN (i.e. 50% of the unbonded gold wire tensile strength). Additionally, the standard deviation is well within the pass criteria of less than 15% of average force.

- Average “As is” Pull Force = 10.9 cN
- Average Pull Force (after 100 hrs) = 12.6 cN
- Average Pull Force after 2000 hours = 10.6 cN

Fig. 4 Average wire pull forces for gold wire bonds following heat conditioning (125°C)

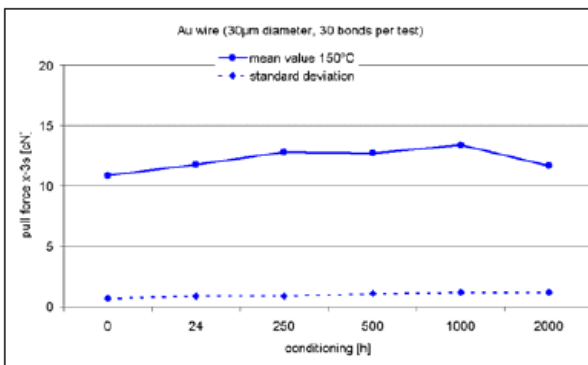
The results of the gold-wire bond tests performed after 150° dry-heat aging are summarized in Figure 5. Again, all pass criteria are achieved.

- Average “As is” Pull Force = 10.9 cN
- Average Pull Force (after 1000 hrs) = 13.4 cN
- Average Pull Force after 2000 hours = 11.7 cN

Fig. 5 Average wire pull forces for gold wire bonds following heat conditioning (150°C)

For the gold-wire bonds, second-bond heel breaks only occurred after 150°C aging, as seen in Figure 8. Other temperature, humidity or thermo-cycle conditioning did not result in any second-bond heel breaks. Interestingly, comparing the results in Figure 8 to Figure 5, the incidence of second-bond heel breaks at 150 °C conditioning did not affect the mean values for the maximum pull forces nor the standard deviation.

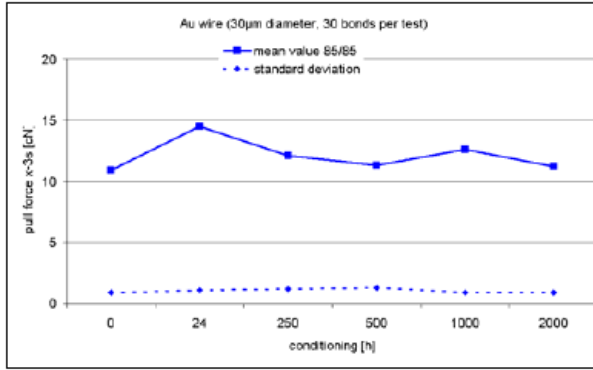
Figure 6 shows the mean values and standard deviations of the pull forces required to break the wire bonds in the heat (85°C) and humidity (85%RH) conditioning test. All pass criteria set forth in Table 4 are again achieved.

- Average “As is” Pull Force = 10.9 cN
- Average Pull Force (after 100 hrs) = 15.8 cN
- Average Pull Force after 2000 hours = 11.2 cN

Fig. 6 Average wire pull forces for gold wire bonds following heat (85°C) and humidity (85%) conditioning

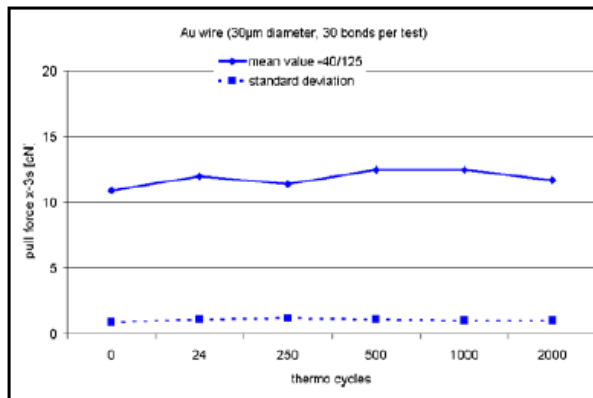
The results of the gold-wire bond tests performed after thermo-cycling are summarized in Figure 7. Thermo-cycling conditions are described in Table 5. Again, all pass criteria are achieved.

- Average “As is” Pull Force = 10.9 cN
- Average Pull Force (after 500 TCs) = 12.6 cN
- Average Pull Force (after 1000 TCs) = 12.6 cN
- Average Pull Force after 2000 hours = 11.7 cN

Fig. 7 Average wire pull forces for gold wire bonds following thermal cycling (-40°C to 125°C)

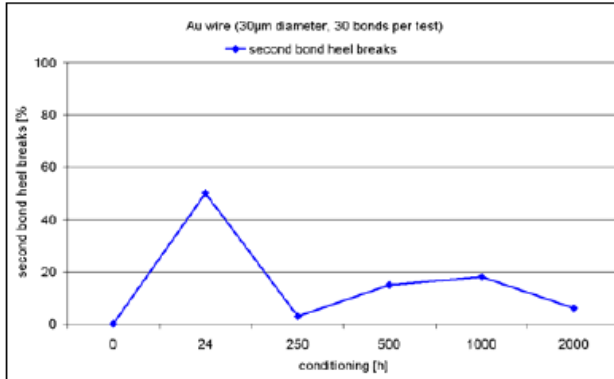
Fig. 8 Incidence of second-bond heel breaks for gold wire bonds following heat conditioning (150°C)

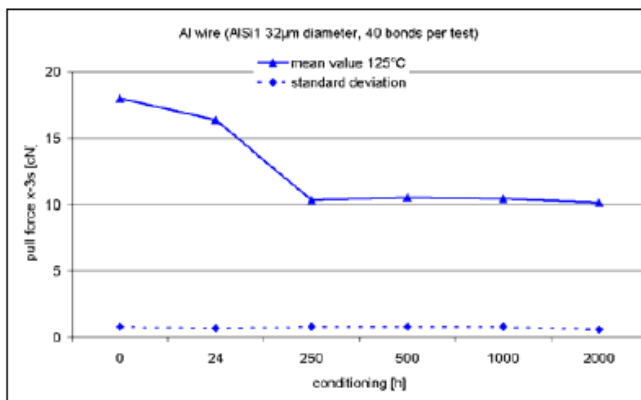
Figure 9 shows the mean values and standard deviations of the pull forces required to break the wire bonds in the 125°C dry-heat conditioning test. As shown, not all values achieved the pass criteria range of 10.5 to 12.0 cN (i.e. 50% of the unbonded aluminum wire tensile strength), although only nominally below the range. However, after 250 hours of conditioning, the average values are only slightly below the lower pass limit. The standard deviation is well within the pass criteria of less than 15% of average force.

- Average “As is” Pull Force = 18.0 cN
- Average Pull Force (after 250 hrs) = 10.3 cN
- Average Pull Force after 2000 hours = 10.1 cN

Fig. 9 Average wire pull forces for aluminum wire bonds following heat conditioning (125°C)

Temperatures of 150 °C will change the physical properties of the aluminum wire after 24 hours, resulting in a decrease in hardness/strength to 2/3 of 'as is' (see Fig. 10 at 24 hours). As expected, at lower temperatures (i.e. 125 °C), these diffusion controlled reactions require additional time (see Fig 9 at 250 hours). While limited to heel breaks or wire breaks, the average pull force of the aluminum wires still decreases to approximately 10 cN. This decrease in tensile strength is strongly influenced by time and temperature, which is a well-known phenomenon with the use of aluminum wires containing even one- or two-percent silica, such as that used in the test (MFD AlSi1). During the manufacturing process of AlSi1 wires the crystal structure is manipulated through welding and temperature treatment. Through diffusion promoted by heating, the smallest silicon precipitations within the aluminium matrix will merge into larger crystals, thereby changing the hardness and strength characteristics of the wire. As such, the structure of the AlSi1 wires (as supplied) has been strongly influenced by the dry heat conditioning of the specimen in these investigations.

Despite the incidence of second-bond wedge lifts after 250 hours of heat/humidity conditioning, Figure 14 shows that the average pull force for second-bond wedge lifts after 2000 hours still maintained a value of slightly more than 10 cN. This result is comparable to the pull forces for the dryheat and thermo-cycle conditioned aluminum wire samples, which apparently lost mechanical hardness and strength through diffusion reactions within the aluminum-silica matrix, as shown in Fig. 9 (at 250 hours), Fig. 10 (at 24 hours), Fig. 12 (at 1000 cycles).

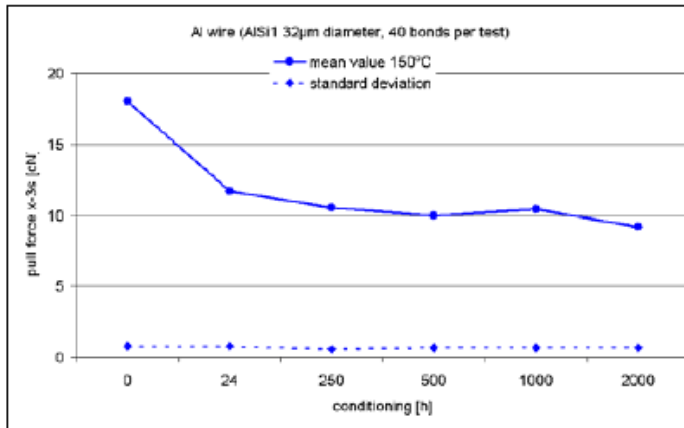
The results of the aluminum-wire bond tests performed after 150° dry-heat aging are summarized in Figure 10. After 250 hours of conditioning, the average pull force remained marginally below the lower range of the pass criteria (10.5 cN).

- Average “As is” Pull Force = 18.0 cN

- Average Pull Force (after 24 hrs) = 11.7 cN
- Average Pull Force after 2000 hours = 9.2 cN

Fig. 10 Average wire pull forces for aluminum wire bonds following heat conditioning (150°C)

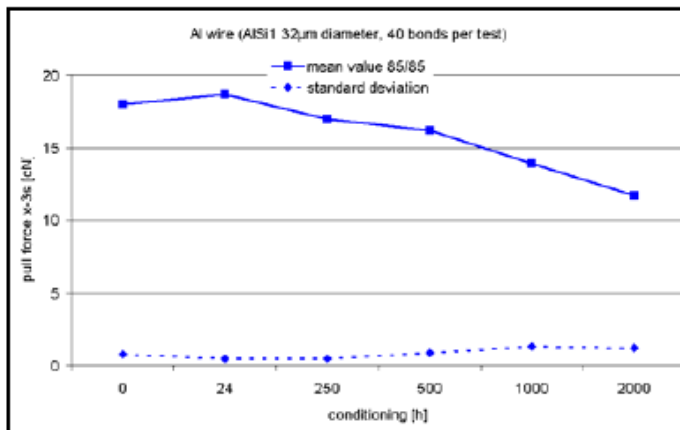
Figure 11 presents the mean values and standard deviations of the pull forces required to break the aluminum wire bonds in the heat (85°C) and humidity (85%RH) conditioning test. All pass criteria set forth in Table 4 are again achieved.

- Average “As is” Pull Force = 18.0 cN
- Average Pull Force (after 24 hrs) = 18.7 cN
- Average Pull Force after 2000 hours = 11.7 cN

Fig. 11 Average wire pull forces for aluminum wire bonds following heat and humidity conditioning

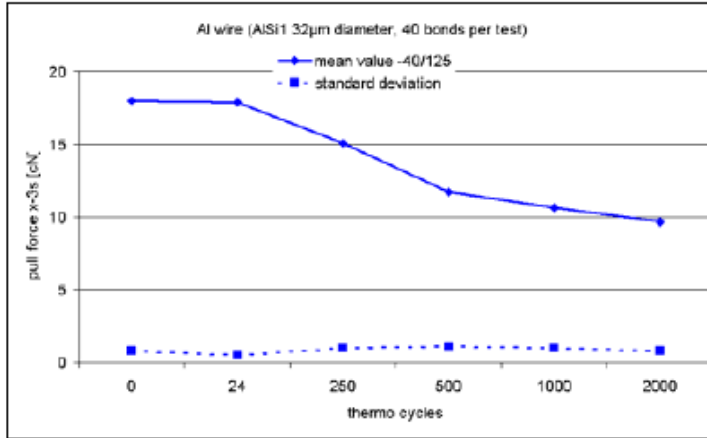
The results of the aluminum-wire bond tests performed after thermo-cycling are summarized in Figure 12. Thermocycling conditions are described in Table 5. Results of pull forces after 1000 thermo cycles averaged just marginally less than the lower limit of the pass criteria, achieving nearly 10 cN.

- Average “As is” Pull Force = 18.0 cN
- Average Pull Force (after 500 TCs) = 11.7 cN
- Average Pull Force after 2000 hours = 9.7 cN

Fig. 12 Average wire pull forces for gold wire bonds following thermal cycling (-40°C to 125°C)

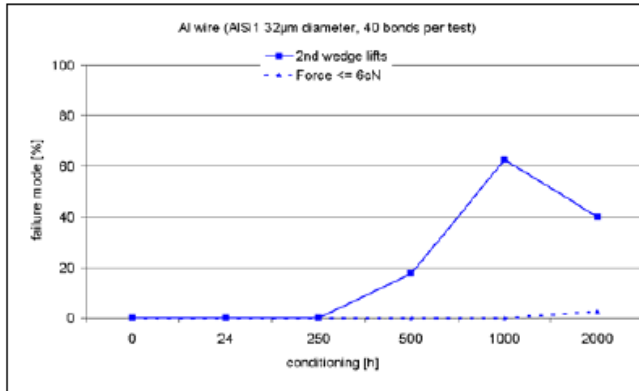
As Figure 13 shows, after 500 hours of high-humidity conditioning (85/85) second wedge lifts occurred in nearly twenty percent of the cases. The previously mentioned temperature-controlled silica diffusion reaction that lowers the mechanical hardness/strength is less of a factor at 85 °C compared to 125 °C or 150 °C. This can be seen by comparing the results in Figure 11 to those in Figures 9 and 10. As such, after extended high-humidity conditioning, second-bond wedge lifts are more prevalent.

Fig. 13 Second-bond wedge lifts and average pull forces ≤ 6 cN for aluminum wire heat (85°C) and humidity (85%) conditioning

The second-bond wedge lifts were subsequently determined to have separated at the gold-palladium interface. SEM EDX analysis clearly showed a gold peak on the AISi1 wire, whereas no gold was detected on the bonding surface. This would seem to indicate a possible adhesion / metallization issue (i.e. gold over palladium), which must be further investigated.

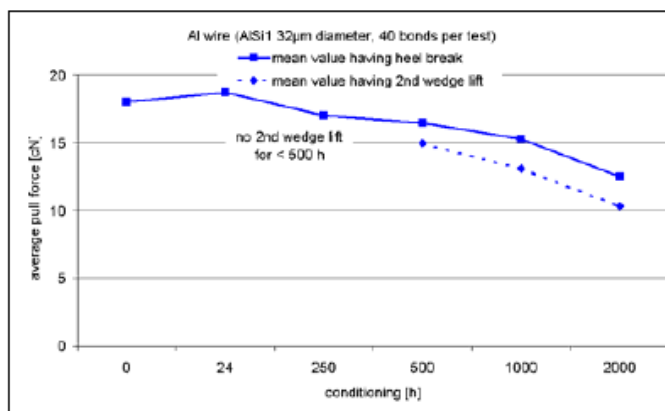
Figure 14 provides a more detailed analysis of the pull forces associated with heel breaks and second-bond wedge lifts. Focusing solely on the average pull forces for heel breaks, it is apparent that the decrease in pull force over time is not as dramatic as that experienced in the dry-heat aging tests. The average pull force after 2000 hours of heat/humidity conditioning still remains 2-3 cN greater than that of the dry heat conditioned samples (See Fig. 9 and 10).

Fig. 14 Average pull forces for aluminum wire heel breaks and second-bond wedge lifts bonds following heat (85°C) and humidity (85%) conditioning

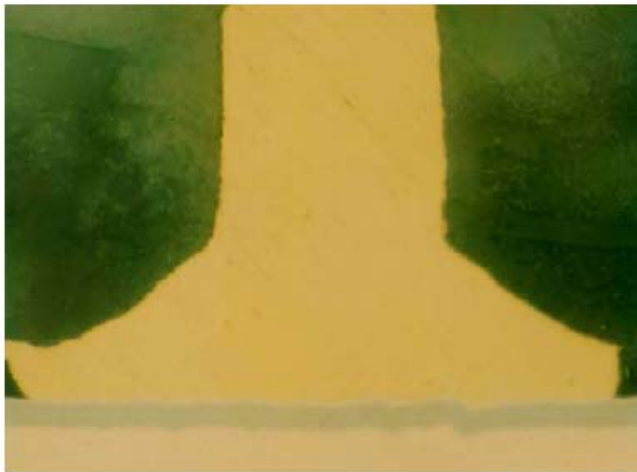
Fig. 15 Image of gold ball bond on Ni/Pd/Au following 2000 hours heat conditioning (150°C)

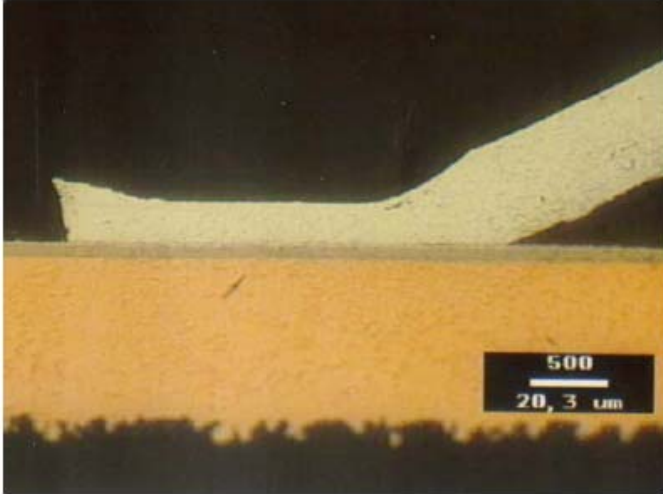
Fig. 16 Image of aluminum wedge bond on Ni/Pd/Au following 2000 hours heat conditioning (150°C)
